## FINAL REPORT

HIMCO SITE  
 ELKHART, INDIANA

Prepared for: Himco Site Trust

**Conestoga-Rovers & Associates**  
 651 Colby Drive  
 Waterloo, Ontario N2V 1C2  
 Canada

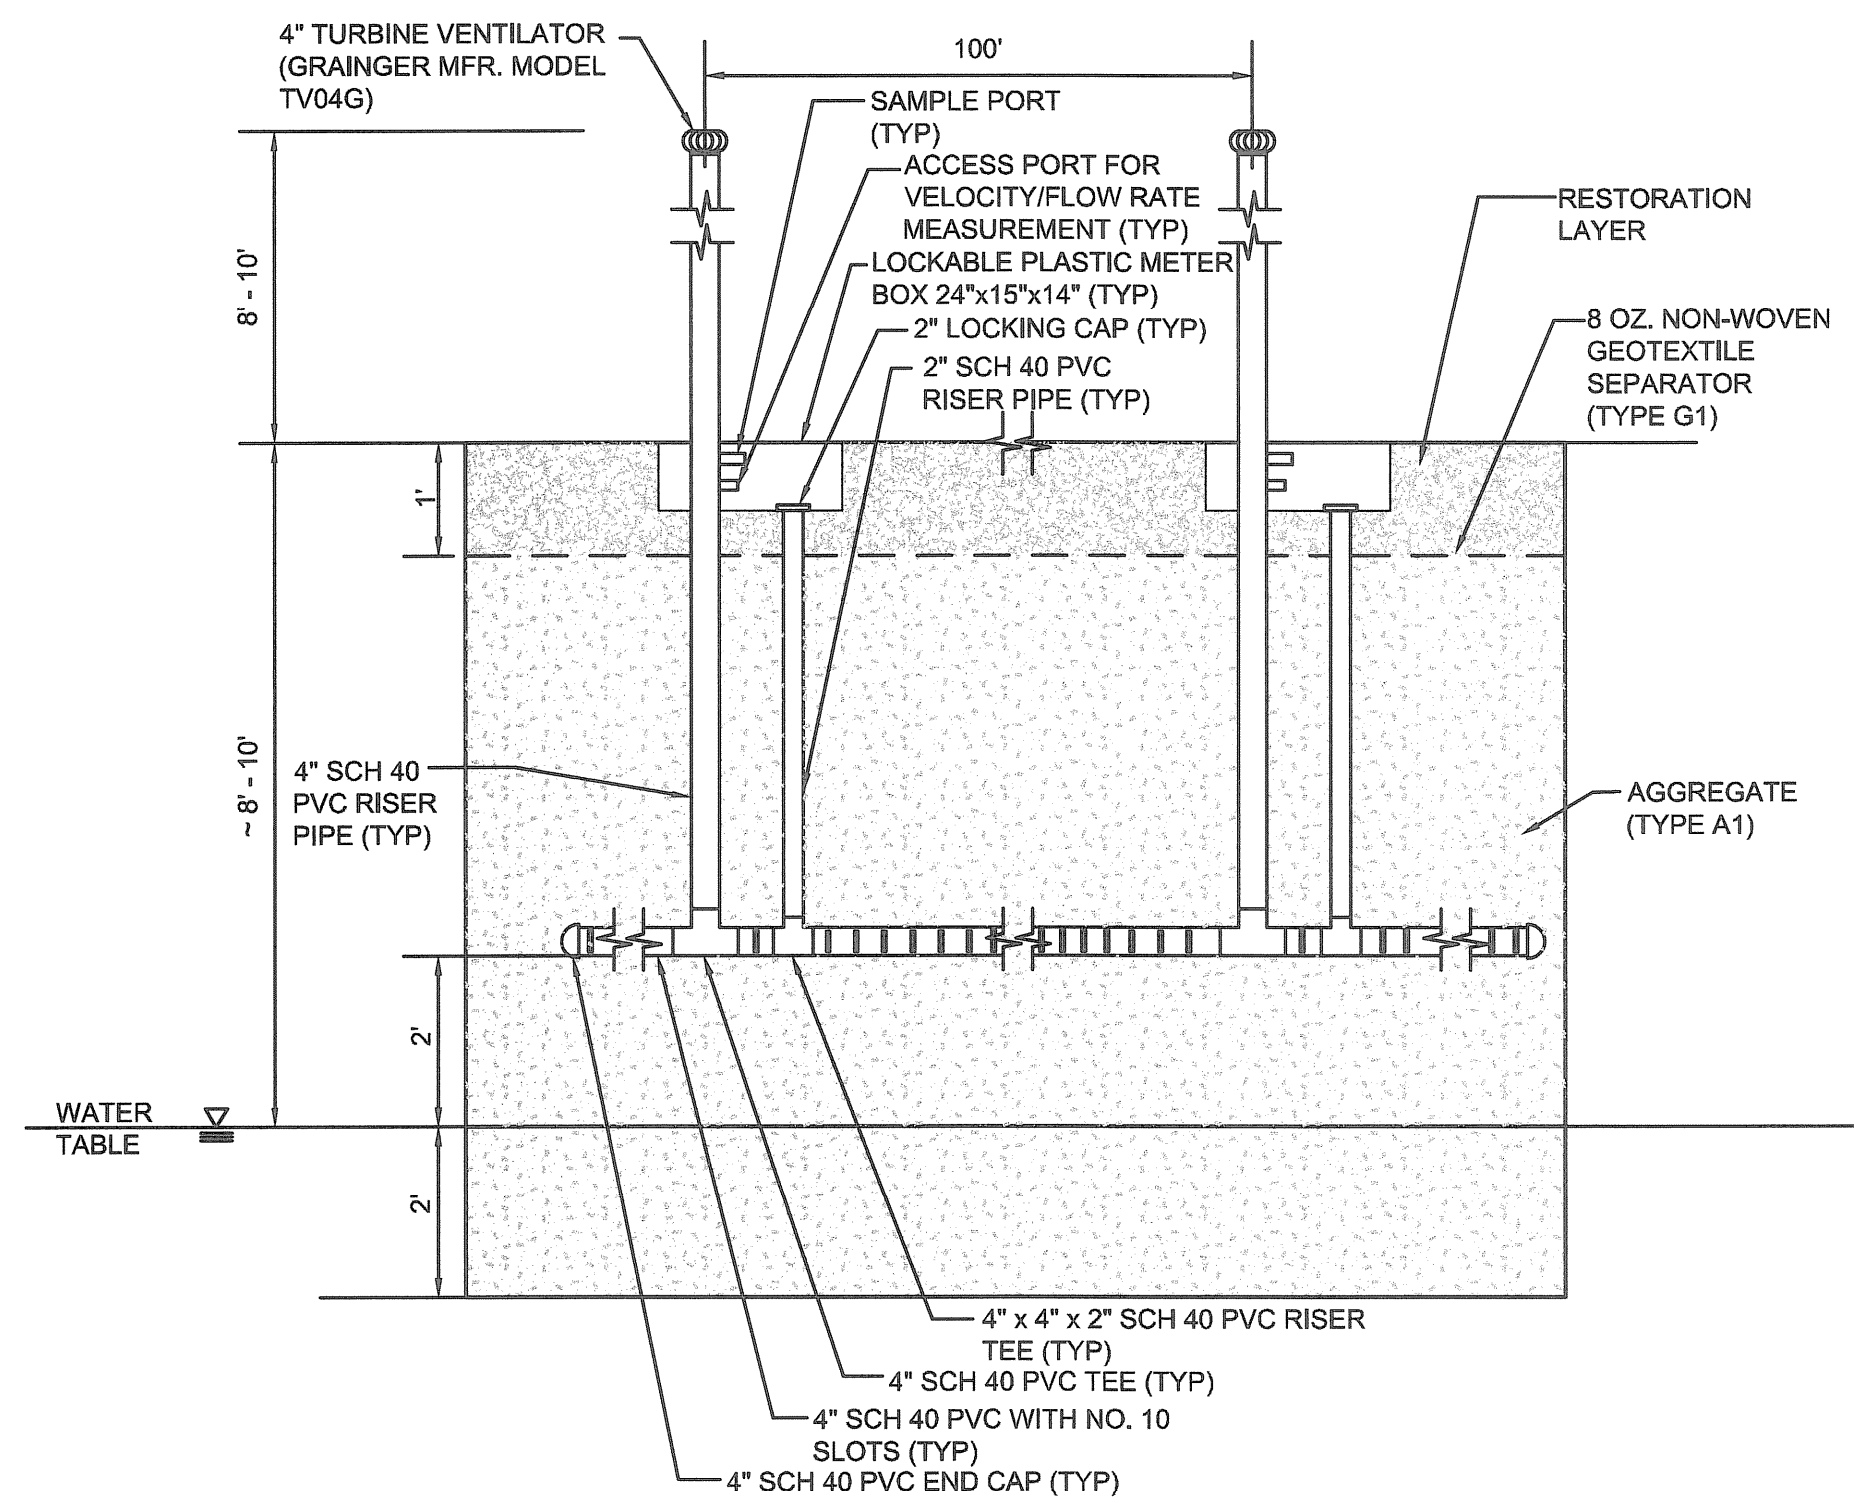
DETAIL 6

TYPICAL PASSIVE VENTILATION TRENCH (PROFILE)

NOTE: FENCE POST NOT SHOWN FOR CLARITY.

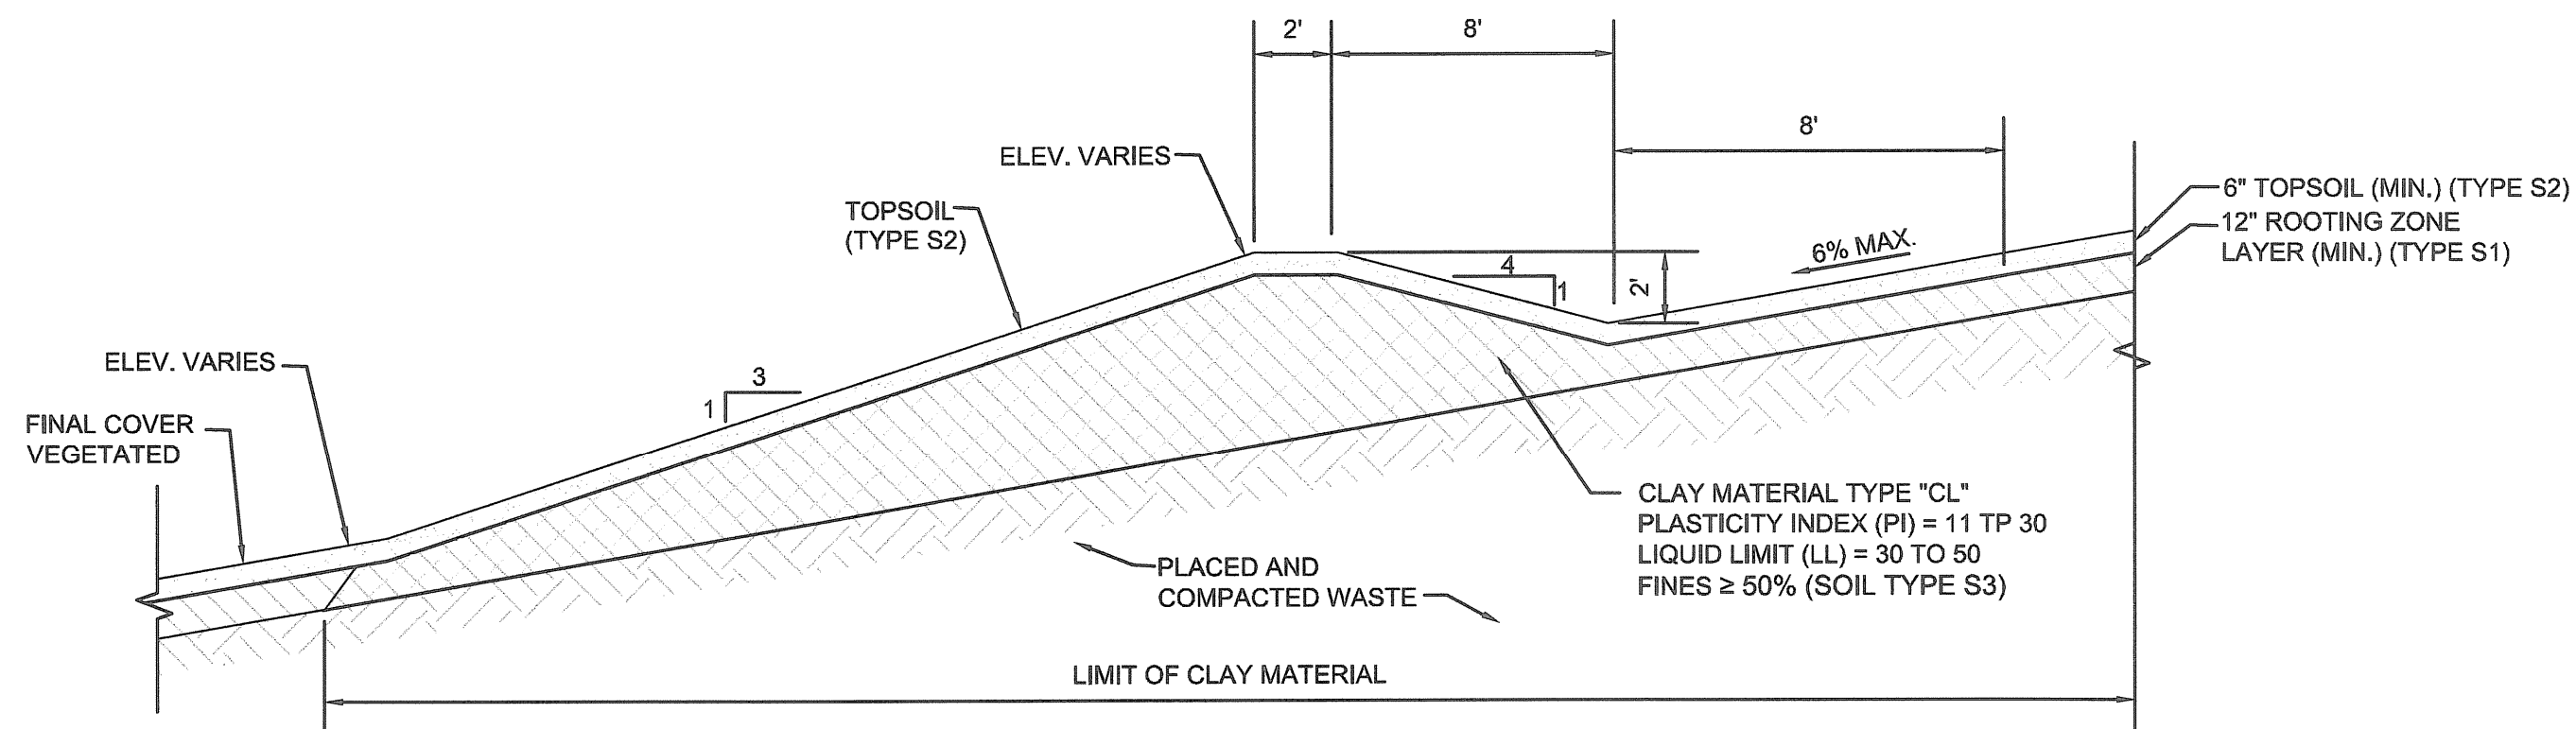
DETAIL 8

COVER SYSTEM STORMWATER DIVERSION BERM

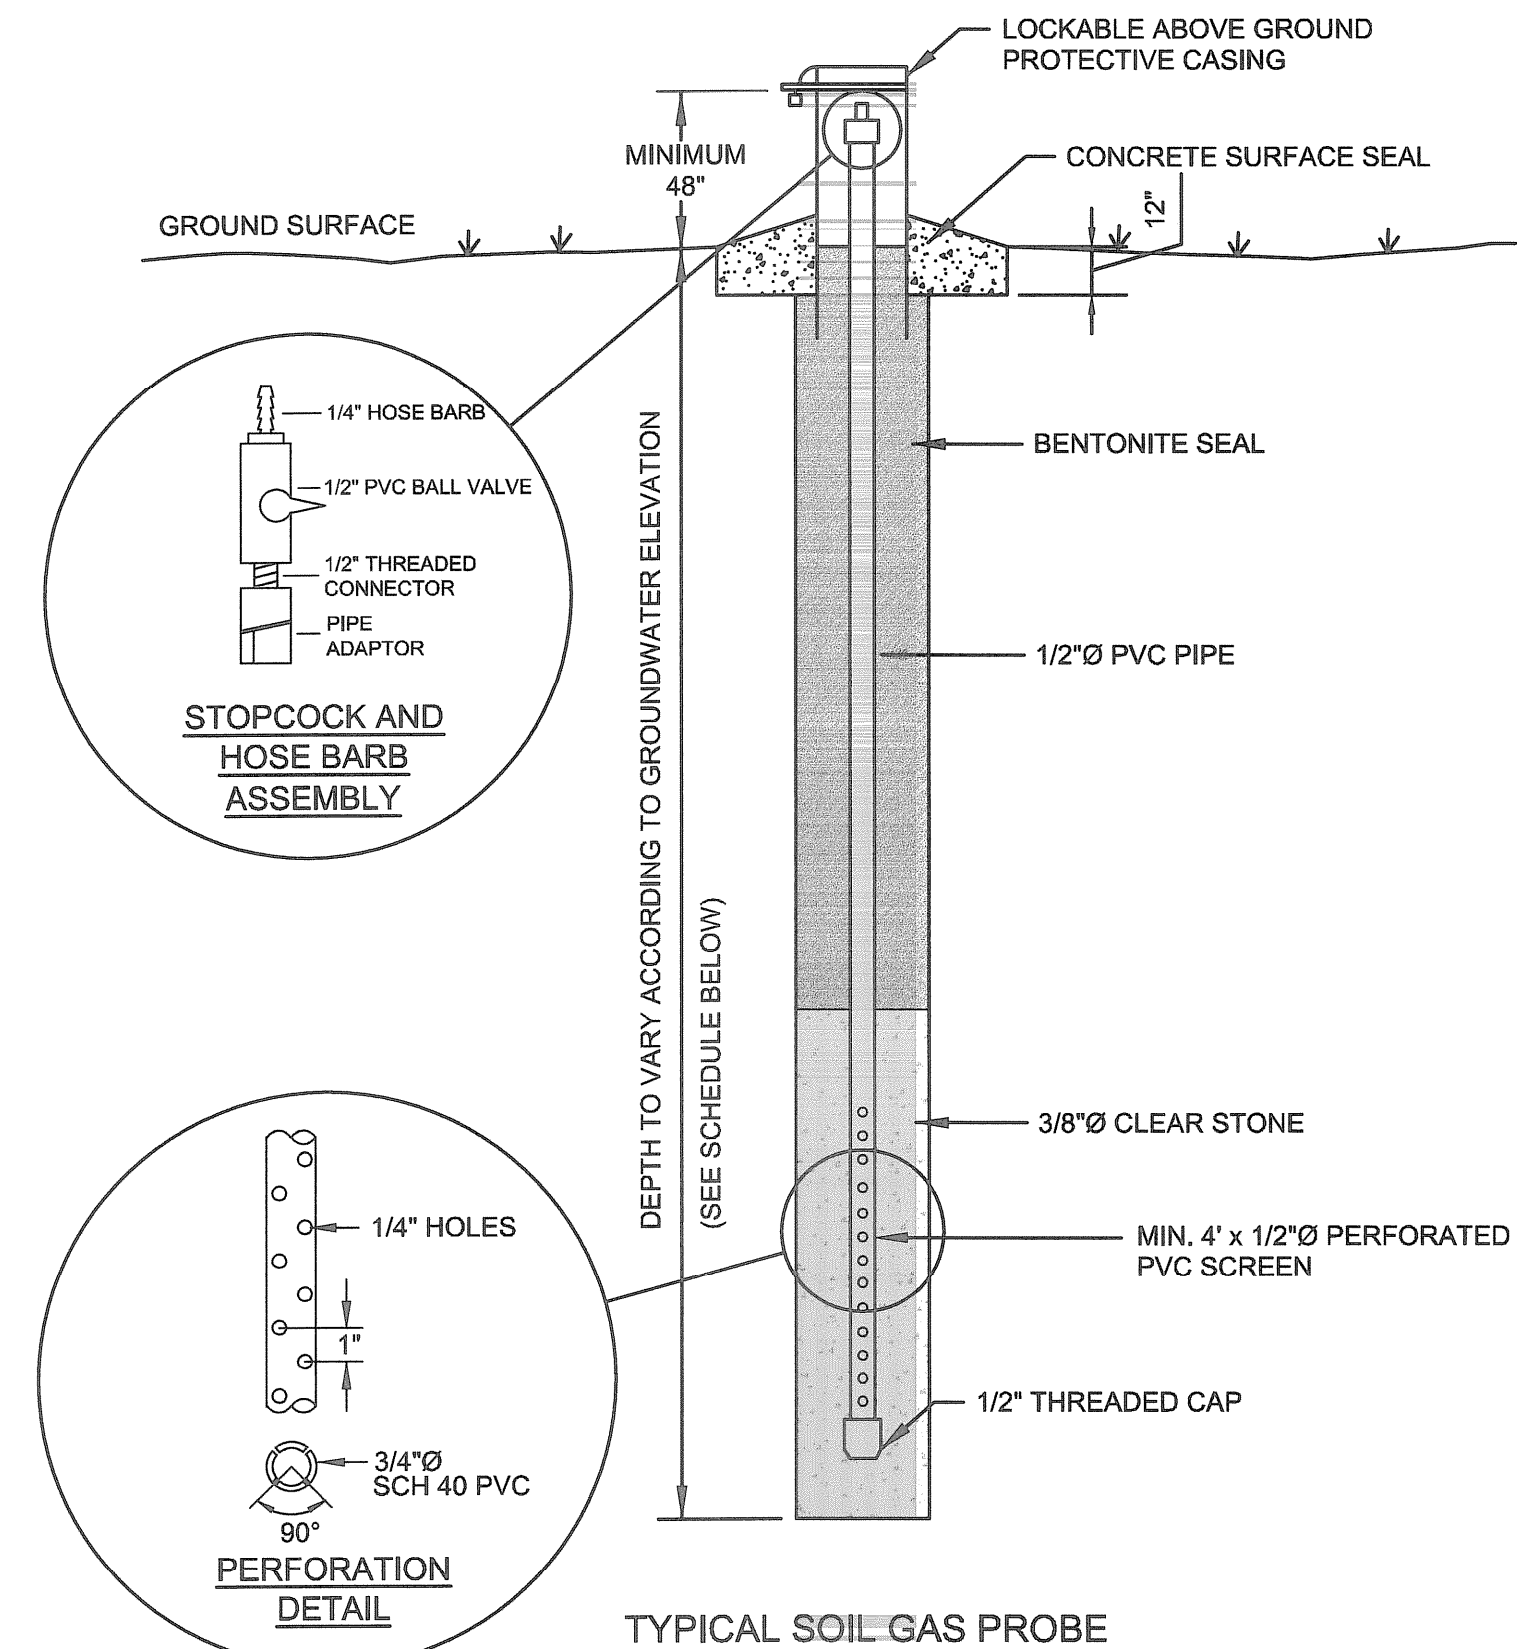
DETAIL 7

TYPICAL SOIL GAS PROBE

The riser pipes for the soil gas probes consist of 1/2-inch diameter Schedule 40 PVC continuous piping (with no joints). CRA installed the riser pipes at varying depths based on the observed groundwater elevation encountered at the time of installation.

The soil gas probe installation depth and lengths of perforated and solid piping are summarized on Drawing No. 10 and installation logs are provided in Appendix I. At each location, CRA installed the soil gas probes at least 1 foot above the local groundwater table observed during the installation.

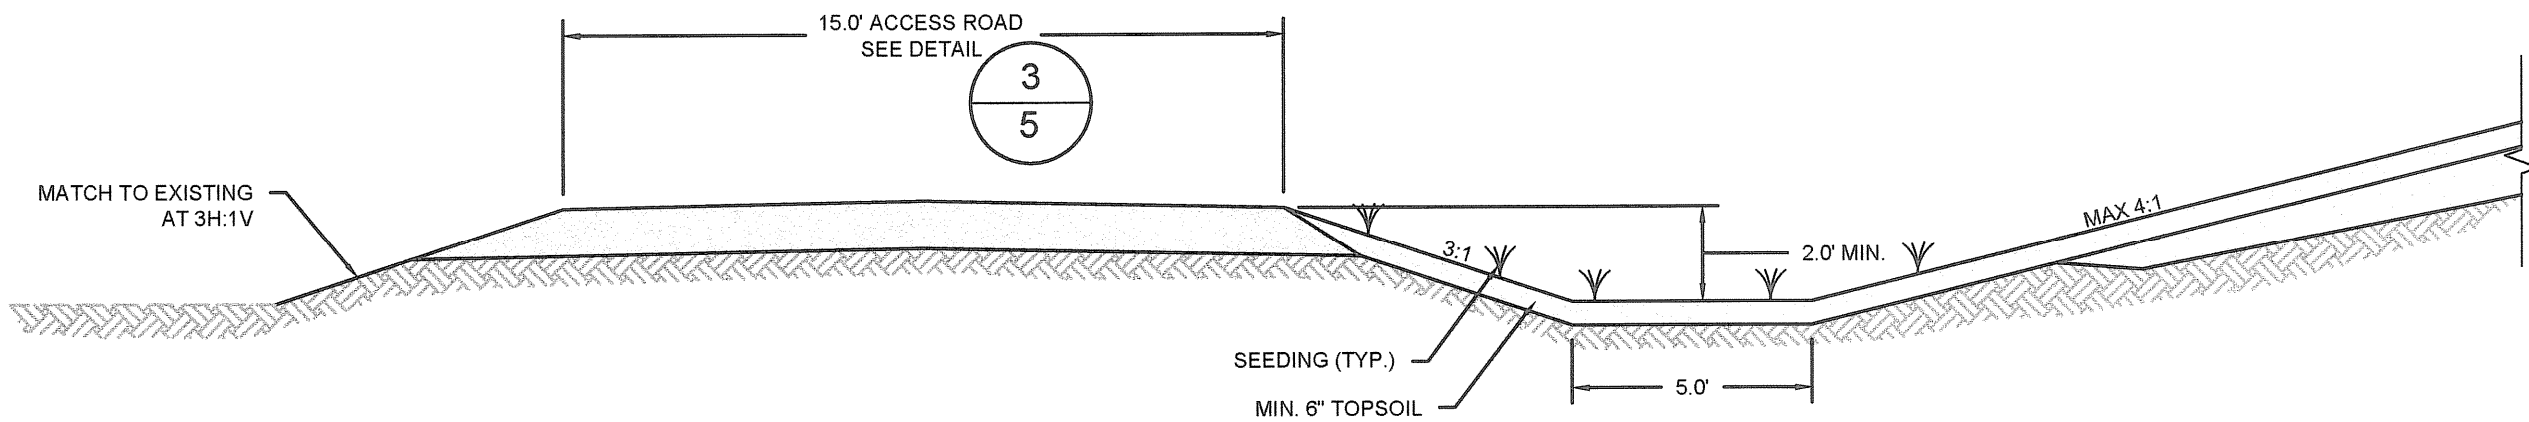
DETAIL 13  
SCALE: 1" = 4'-0"

TYPICAL PERIMETER SWALE

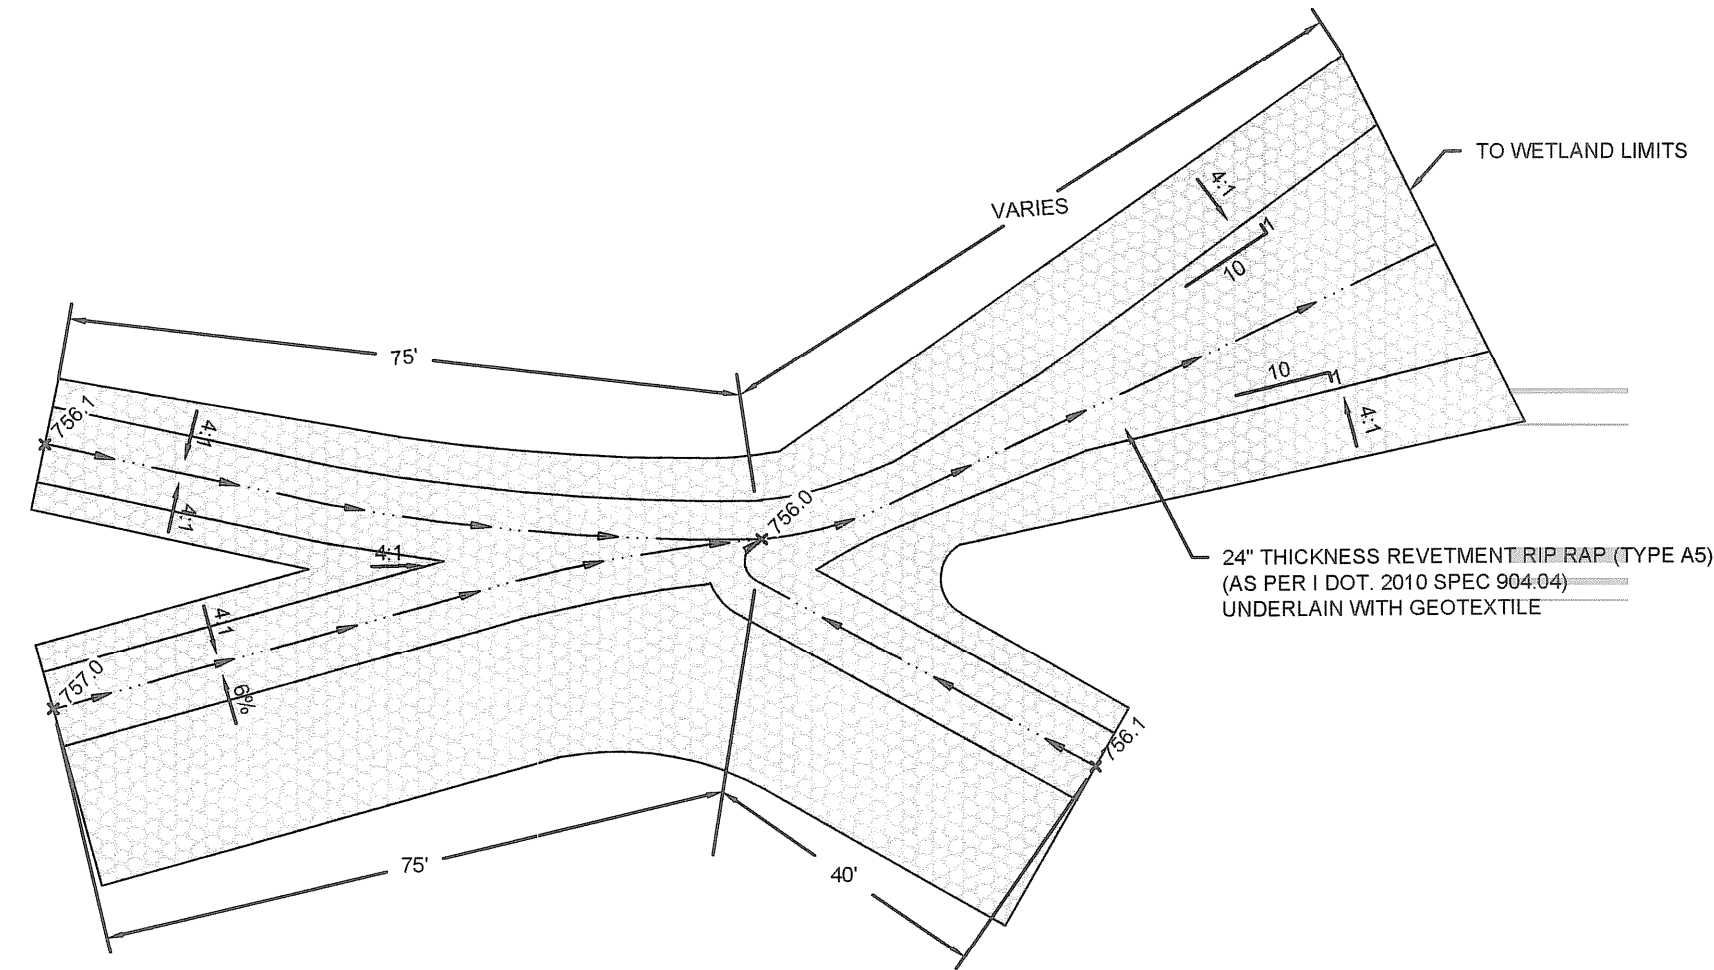
DETAIL 14  
SCALE: NONE

NOTE: RIPRAP LINING TO EXTEND MINIMUM 2' VERTICALLY

RIPRAP LINED CONFLUENCE AND APRON

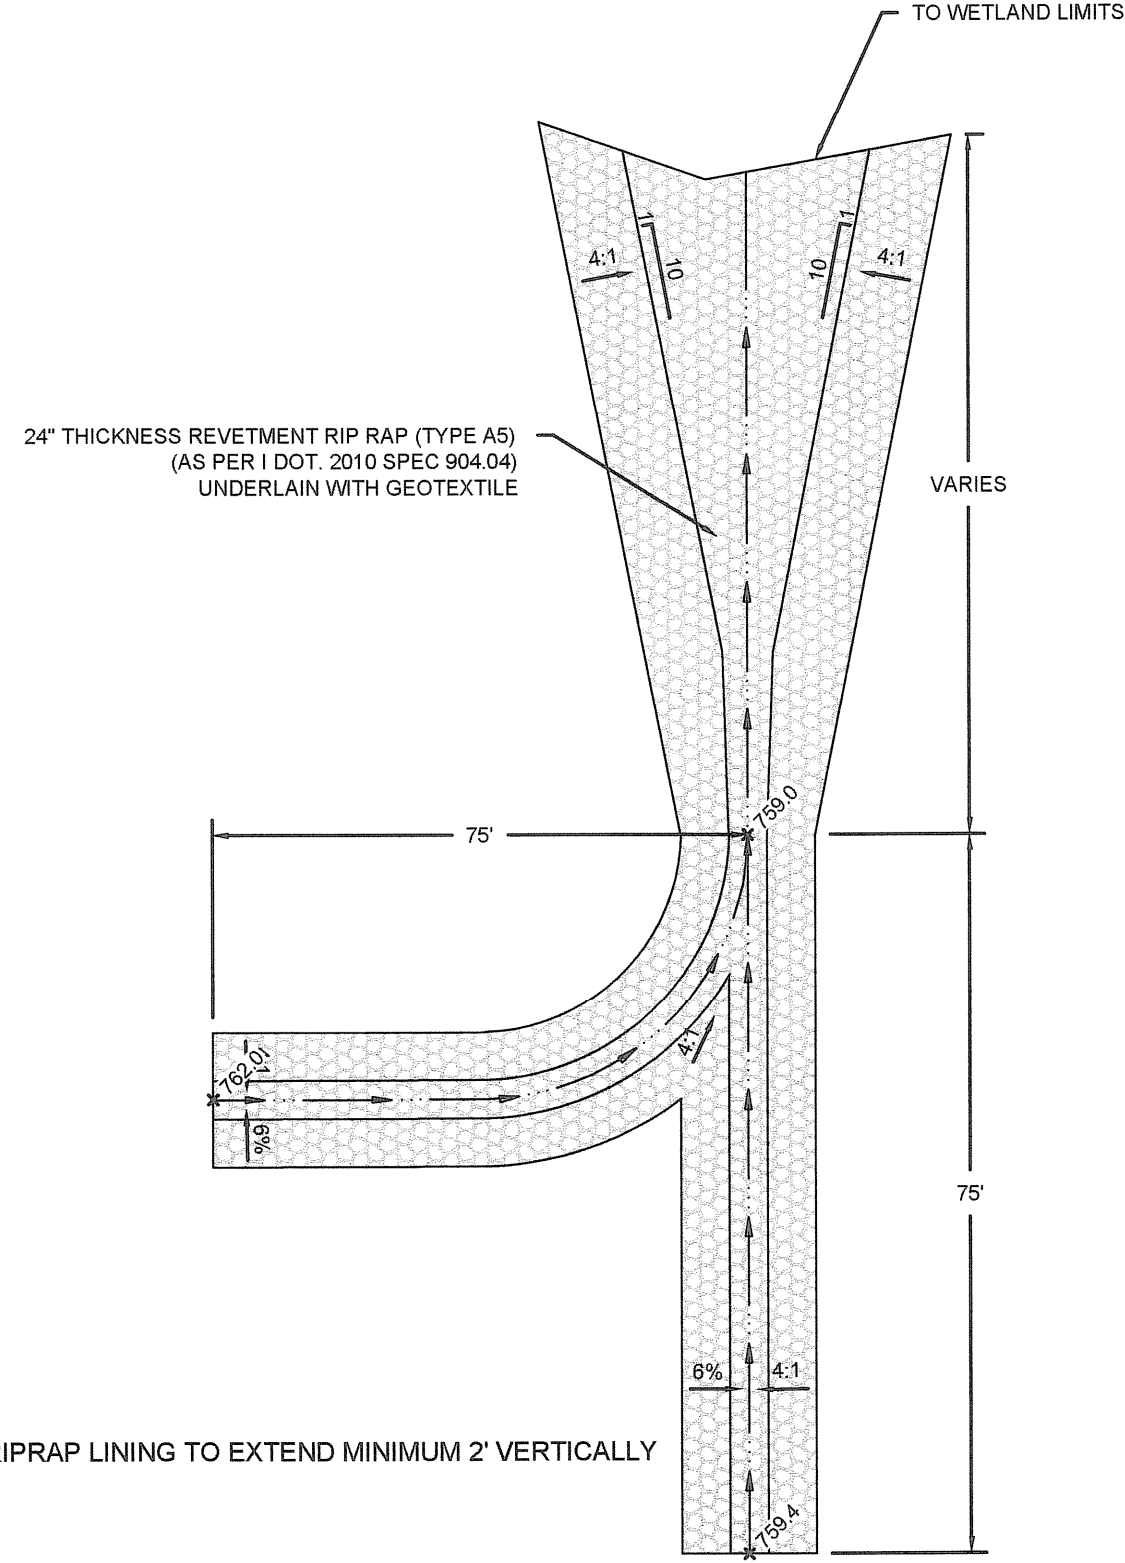
DETAIL 15  
SCALE: NONE

NOTE: RIPRAP LINING TO EXTEND MINIMUM 2' VERTICALLY

RIPRAP LINED CONFLUENCE AND APRON

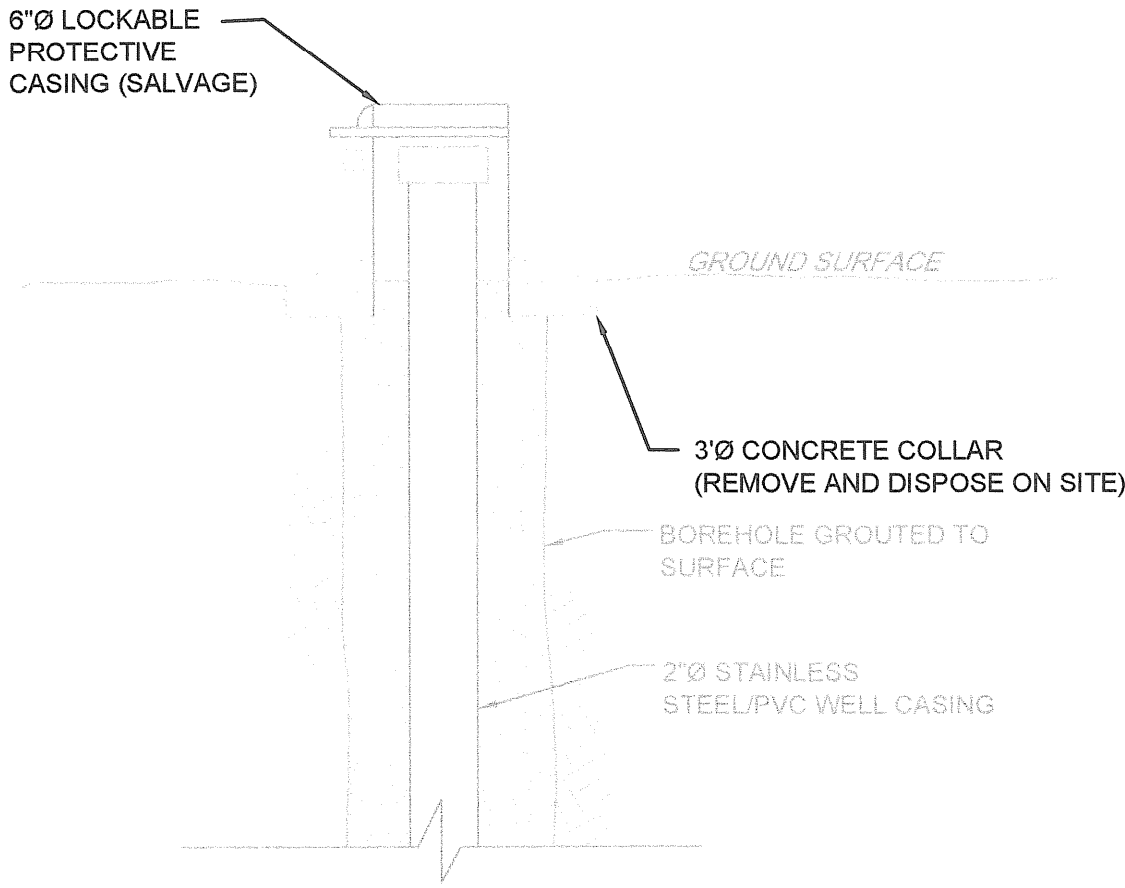
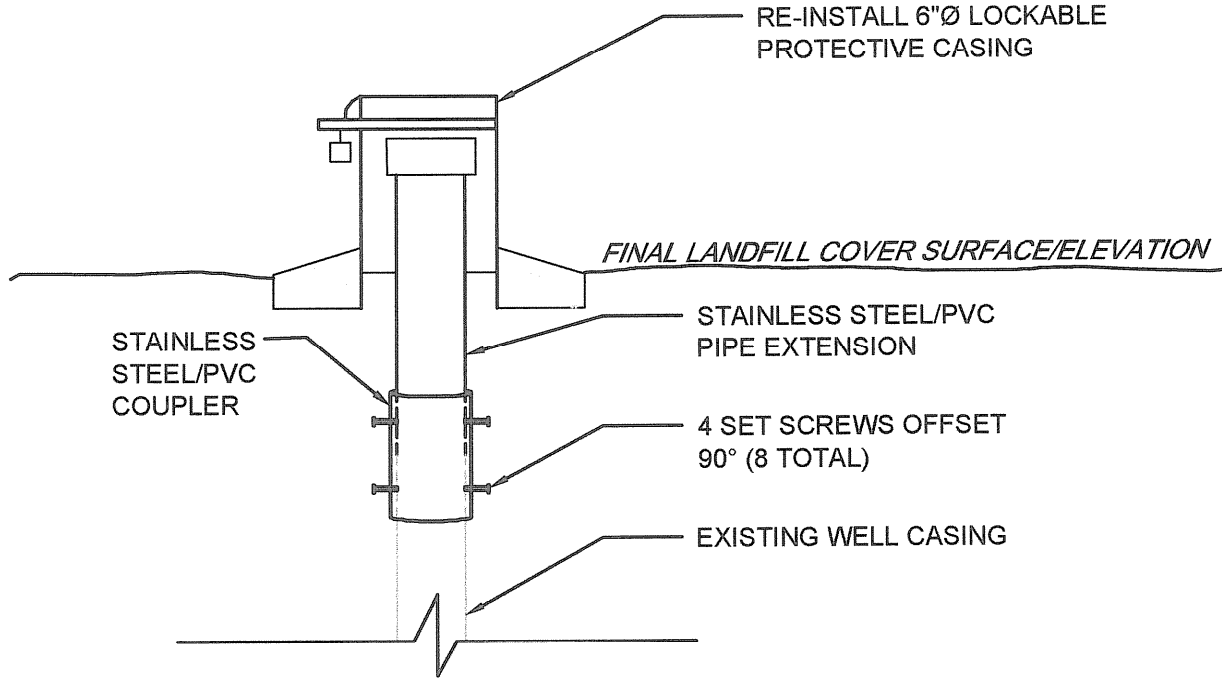
MONITORING WELL EXTENSION

NOTE: CONTRACTOR TO INSTALL SET SCREWS WITHOUT FULLY PENETRATING WELL CASING.

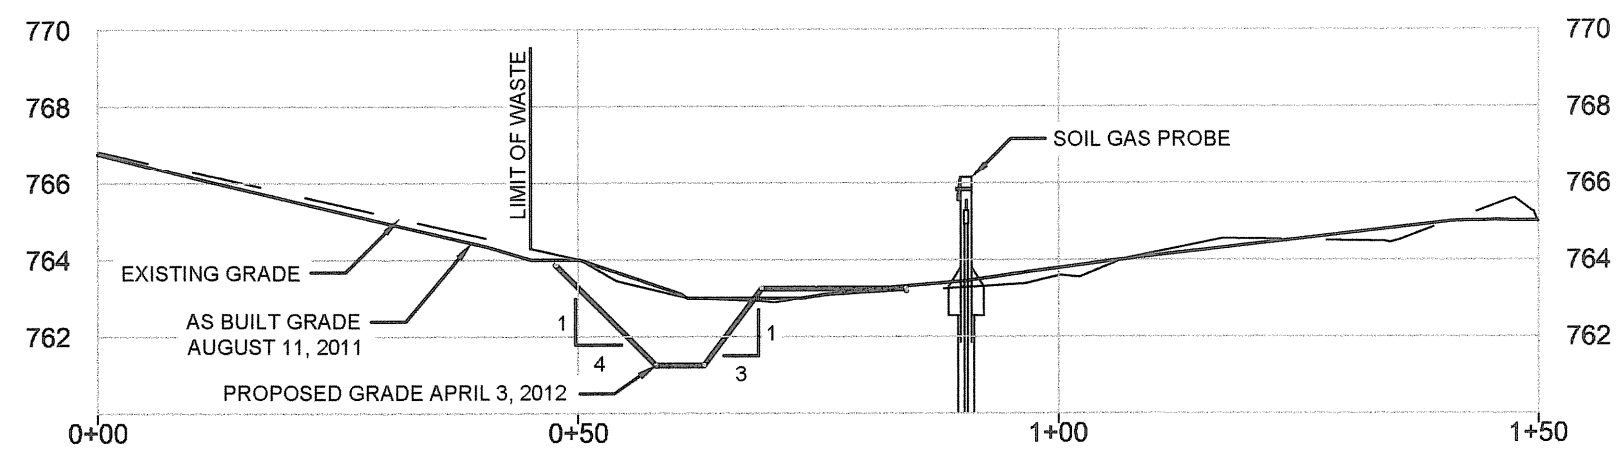
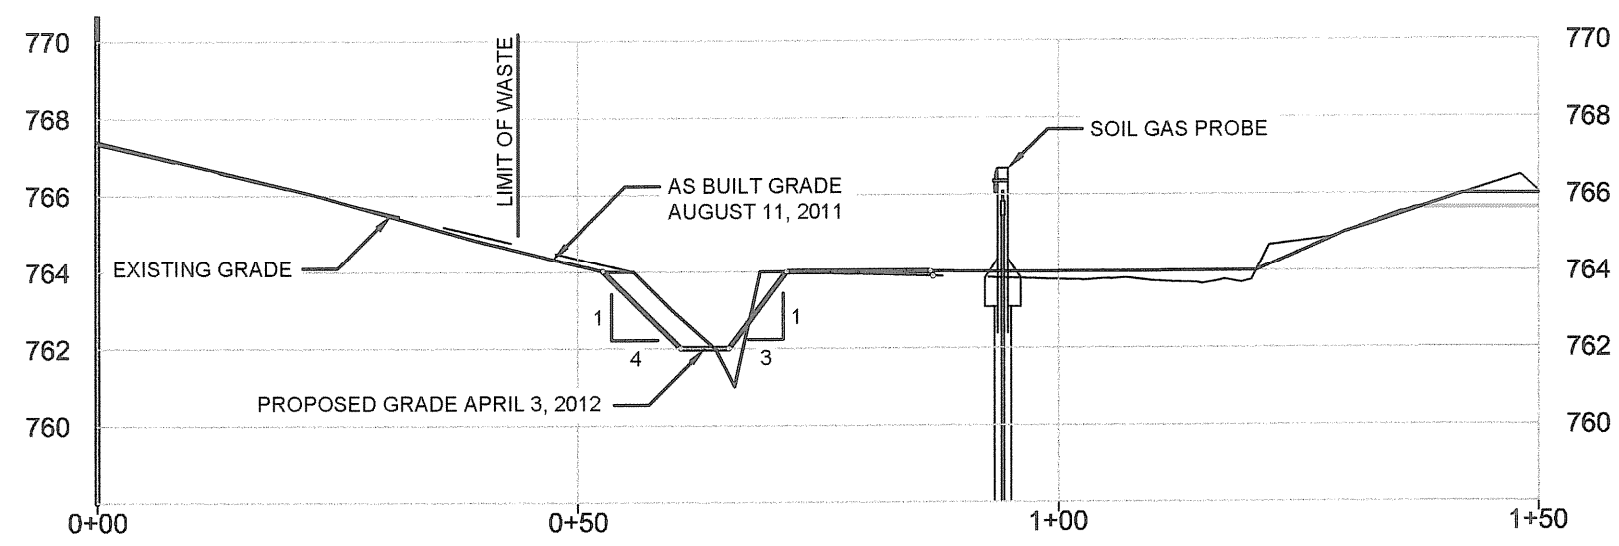
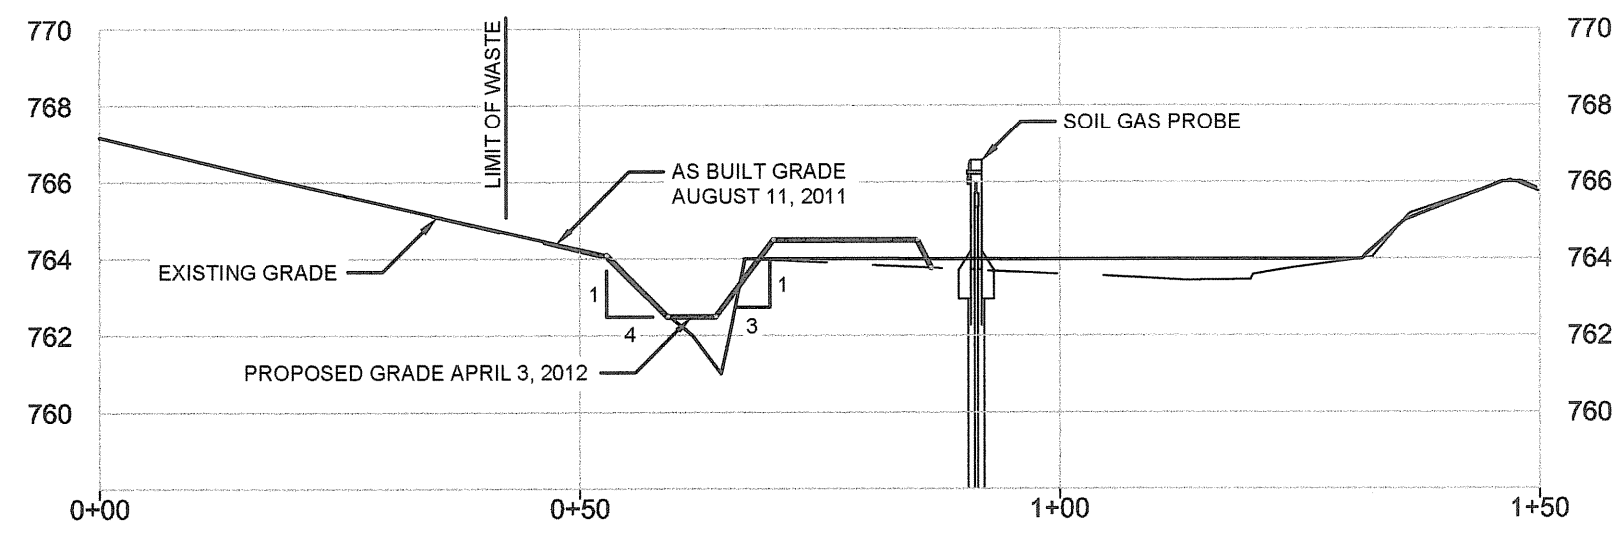
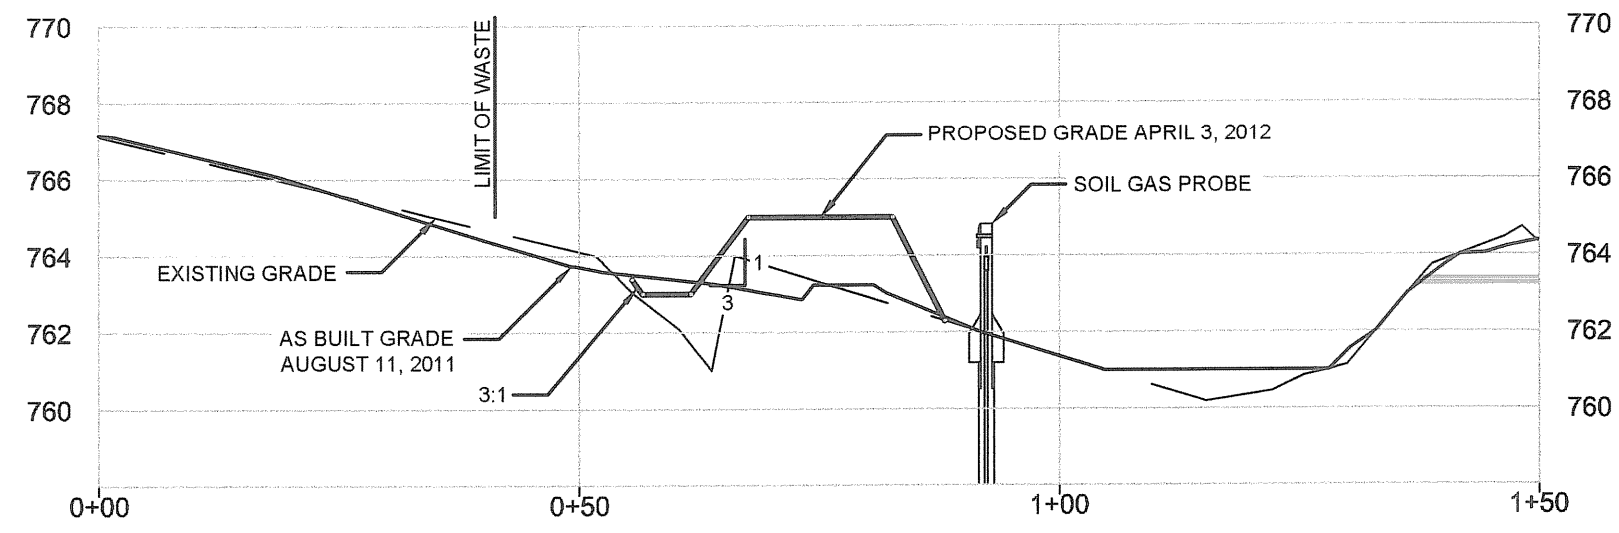
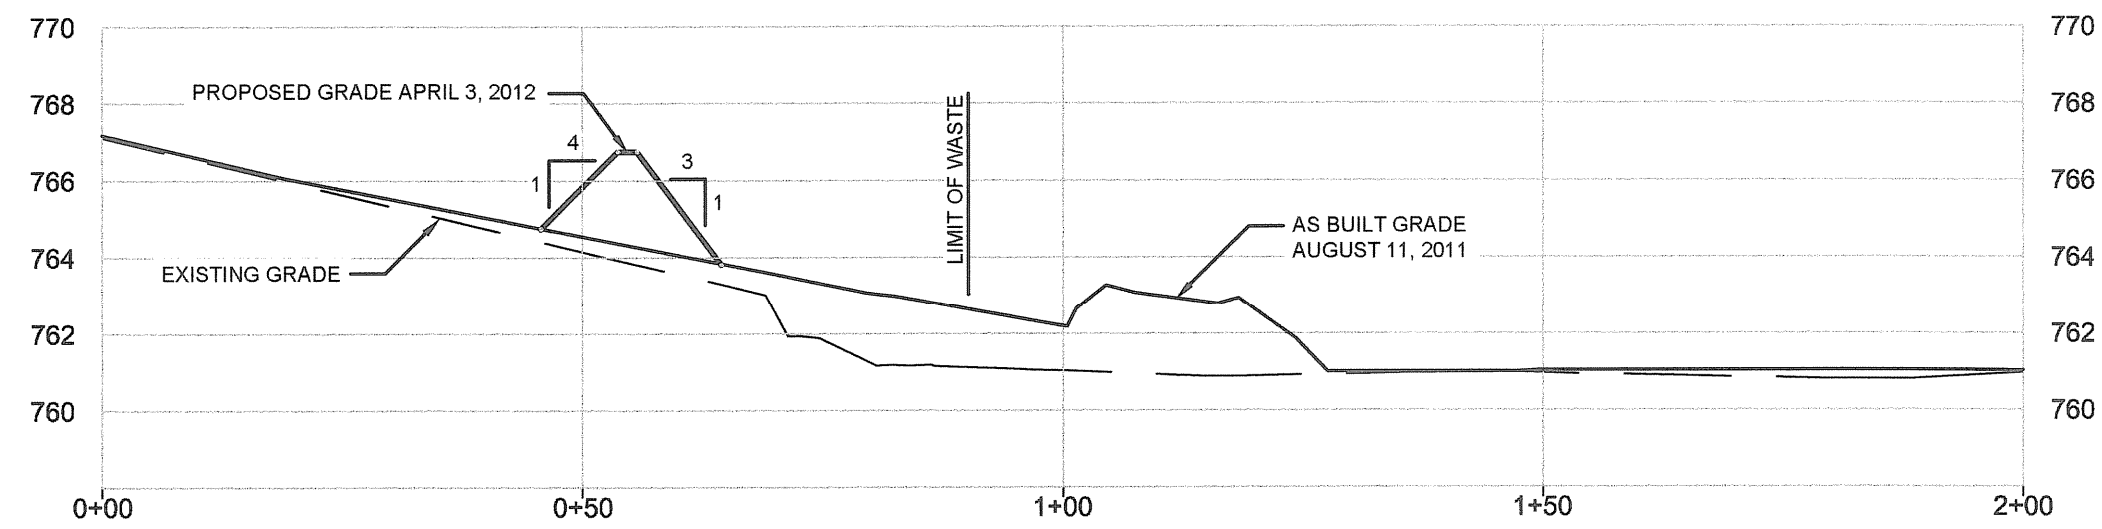
SECTION **A** AT SGP-100  
HORIZ 1:20  
VERT 1:5

SECTION **B** AT SGP-101  
HORIZ 1:20  
VERT 1:5

SECTION **C** AT SGP-102  
HORIZ 1:20  
VERT 1:5

SECTION **D** AT SGP-103  
HORIZ 1:20  
VERT 1:5

SECTION **E** AT SGP-104  
HORIZ 1:20  
VERT 1:5

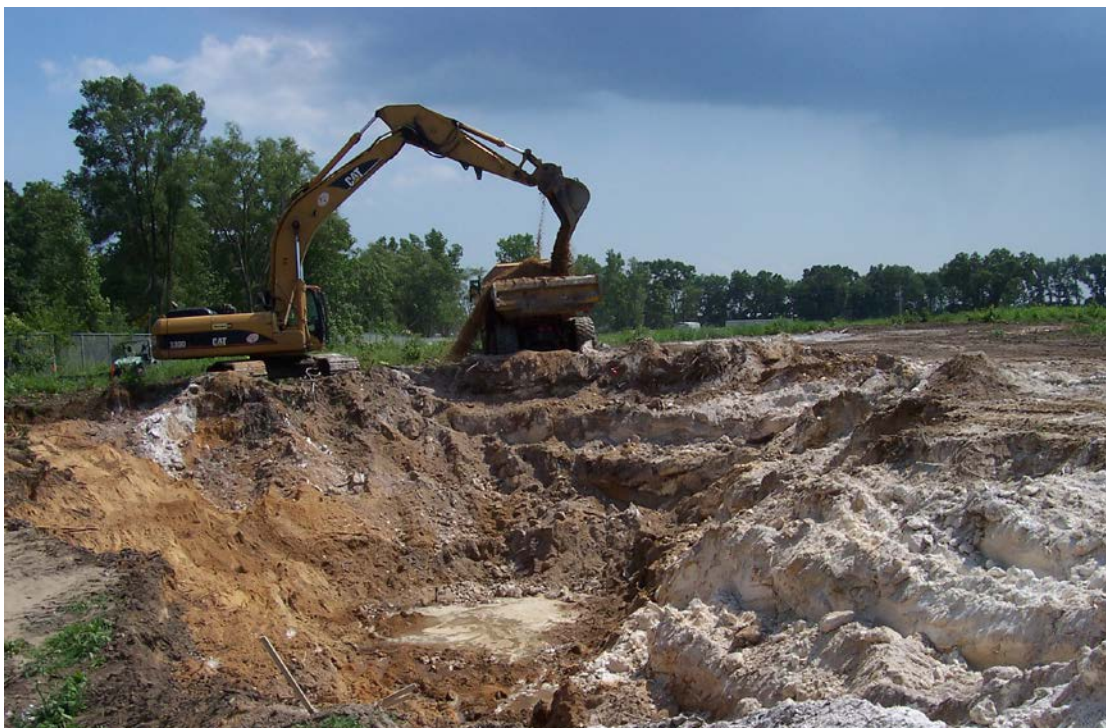
Photo 2: Relocation of Waste near Northwest Perimeter of Landfill- 2011

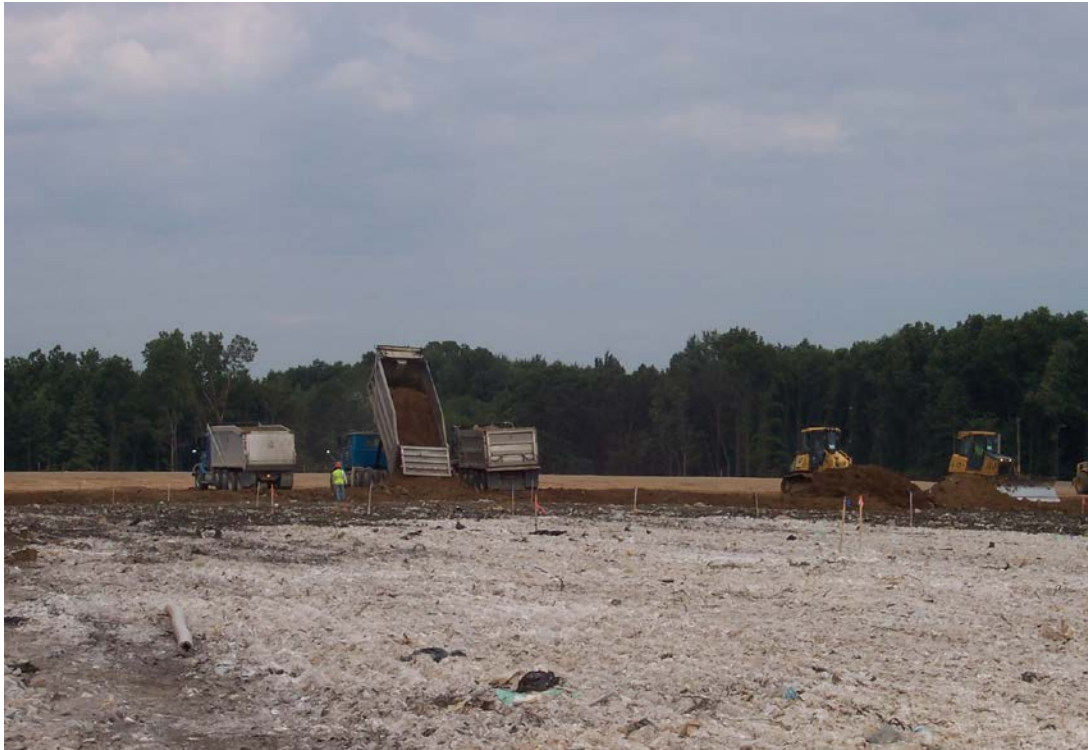
Photo 3: Regrading of Landfill and Rooting Zone Placement - 2011

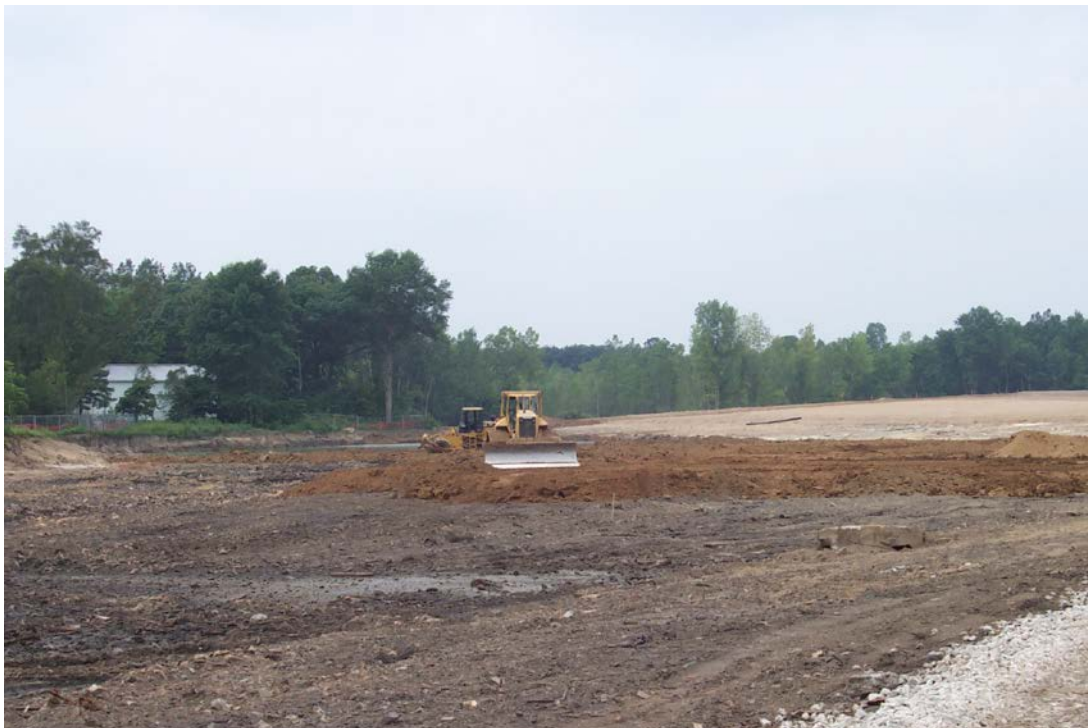
Photo 4: Common Fill Placement in CDA Area - 2011

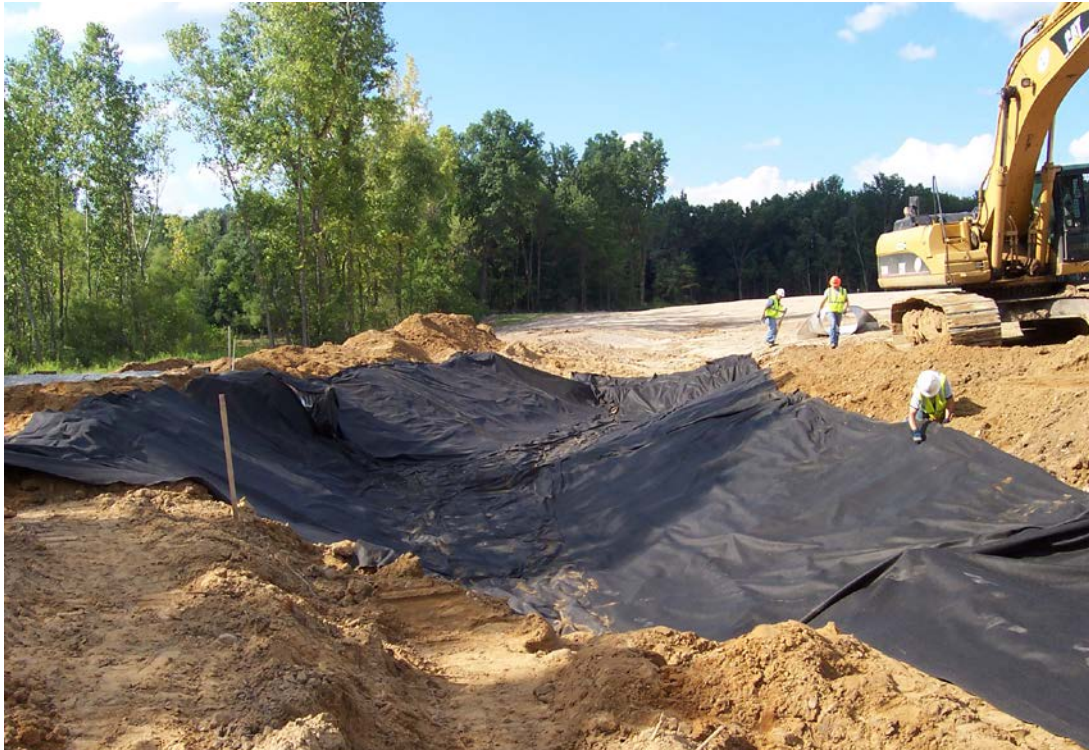
Photo 5: Placement of Geotextile for Rip Rap Installation near West Ponds - 2012

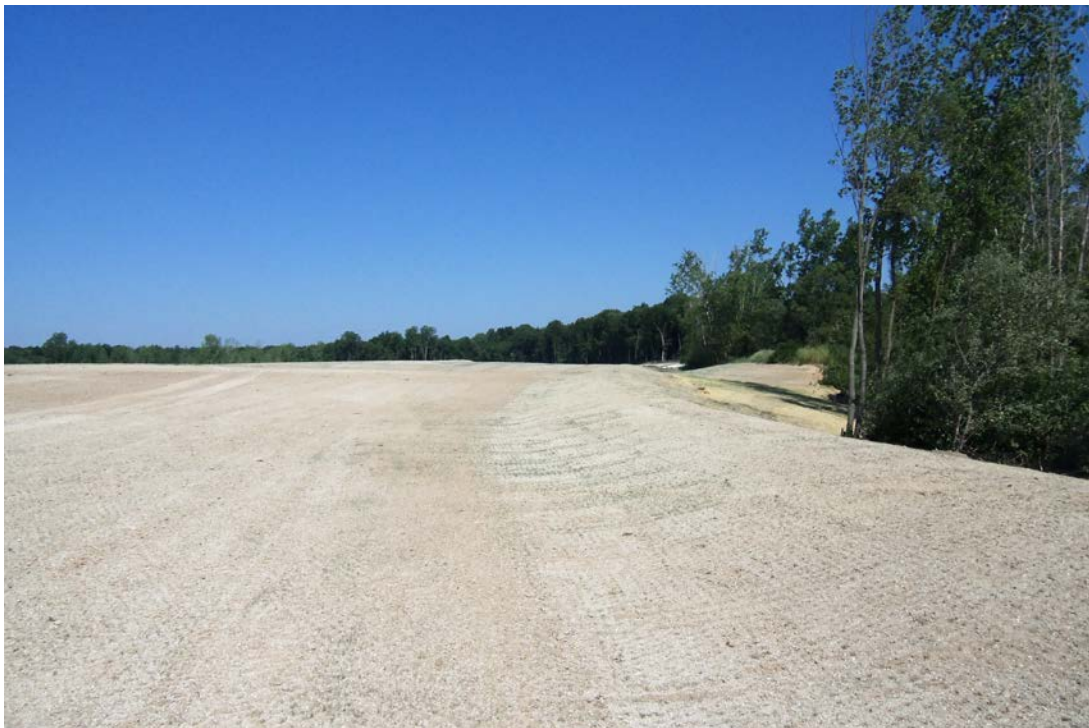
Photo 6: Final Cover - 2012

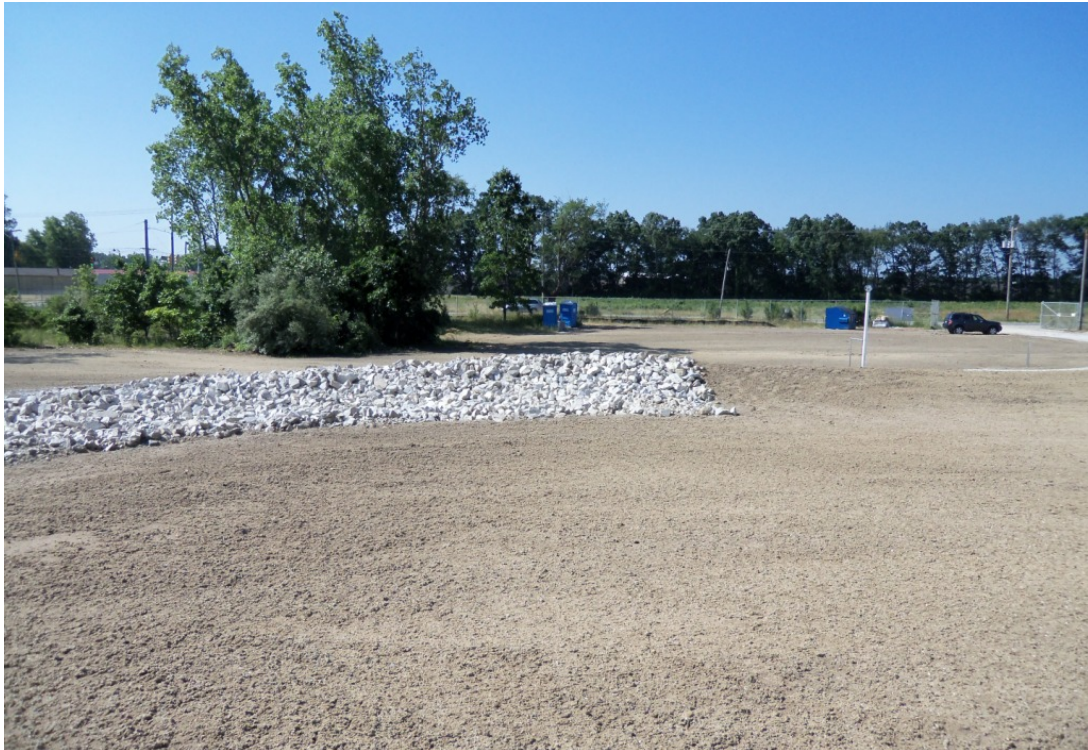
Photo 7: Final Cover and Passive Ventilation Trench - 2012
